Title: Product weathertightness testing of a sample of MC 600 Curtain Walling for Smart Systems Limited

Report No: N950-12-16555

Client: Smart Systems Ltd, Arnolds Way, Yatton, North Somerset, BS49 4QN

Issue date: 25 September 2012

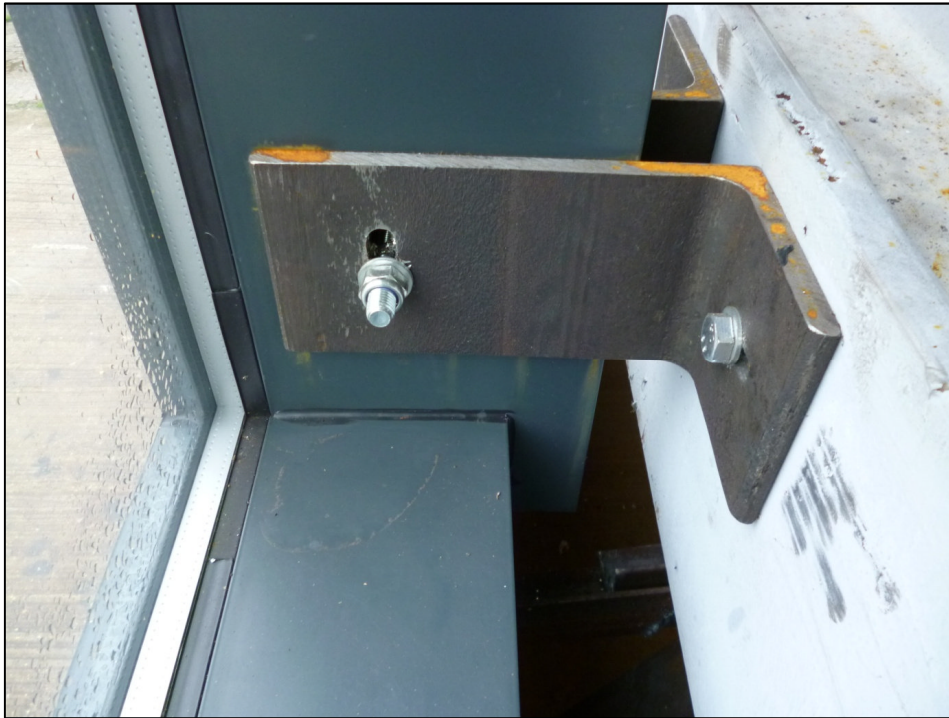
PHOTO 1010956

STEEL SUPPORT BRACKET

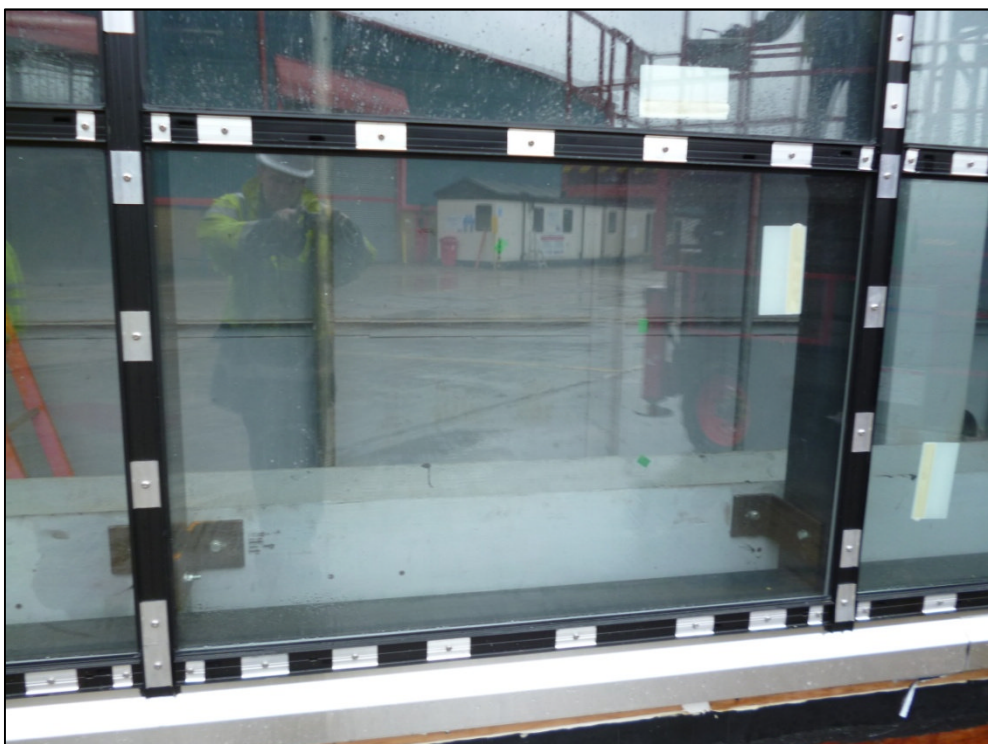
PHOTO 1010960

During the dismantling of the sample no water penetration or discrepancies from the drawings were found.

FRAME COVER CAPS REMOVED

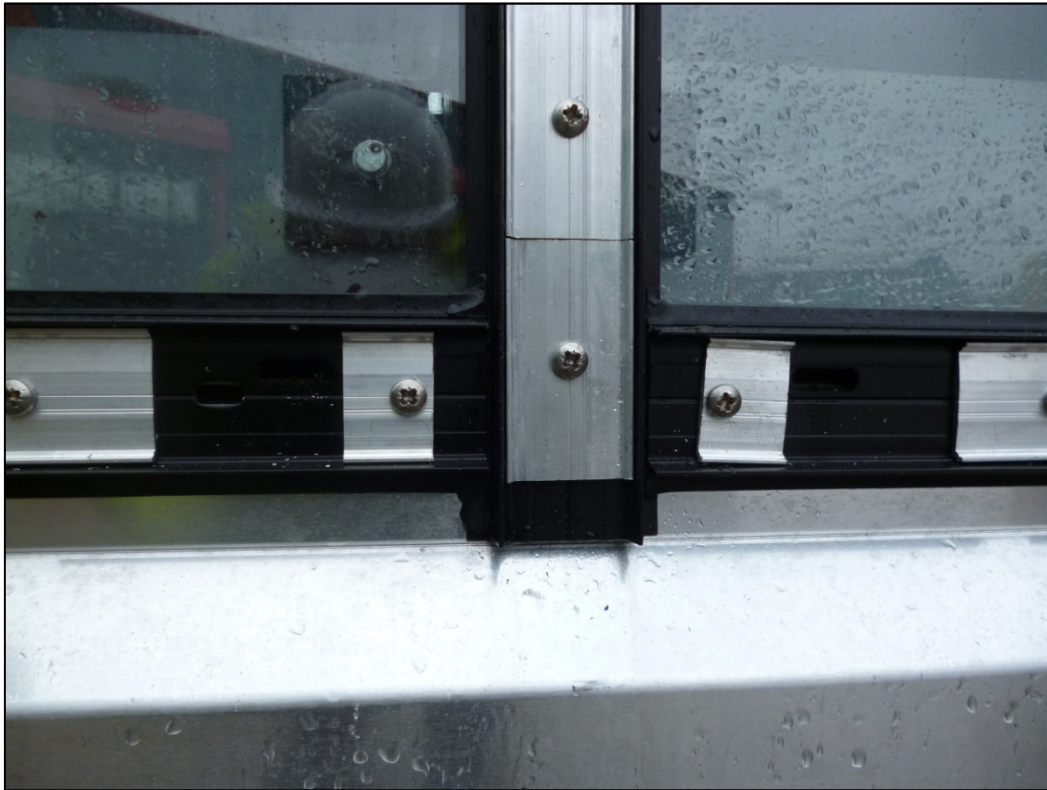
PHOTO 1010961

VIEW AT BASE OF MULLION

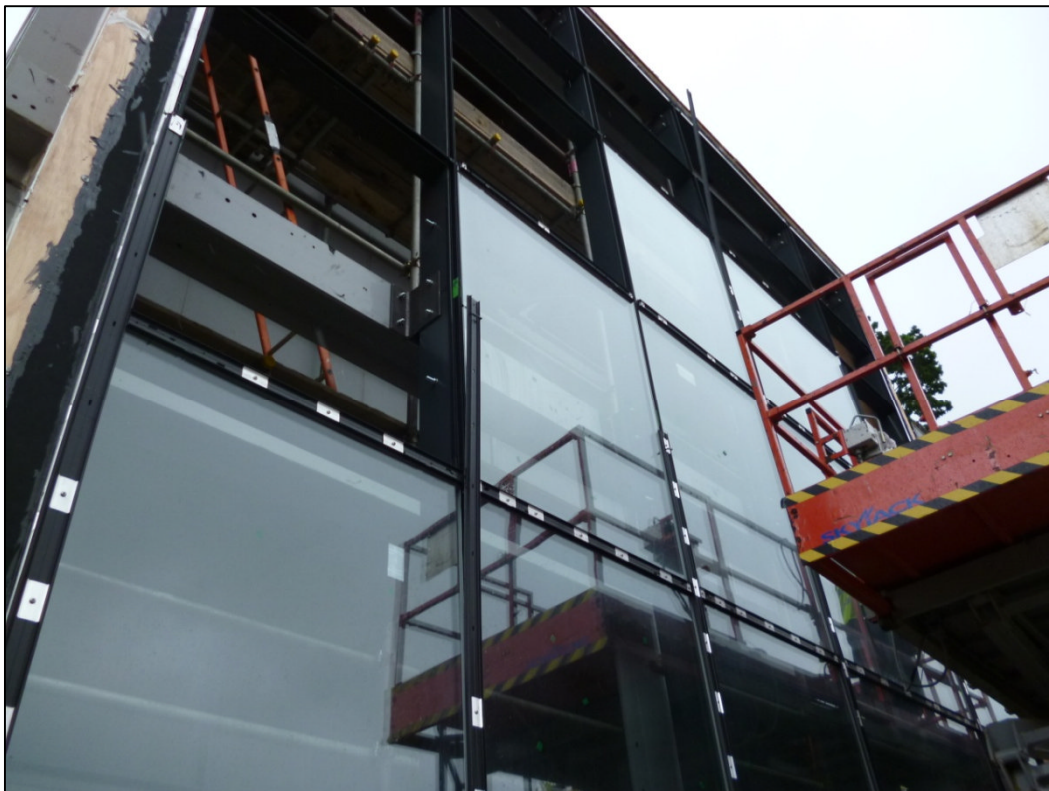
PHOTO 1010963

SAMPLE DURING DISMANTLE

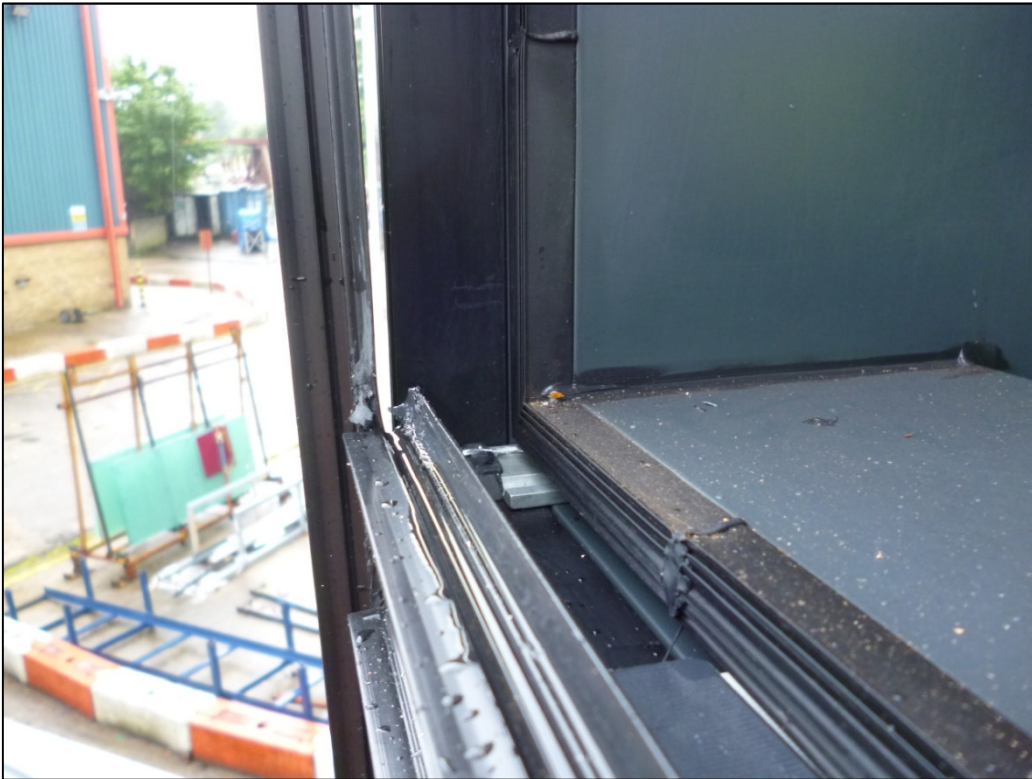
PHOTO 1010965

FRAME WITH GLASS REMOVED

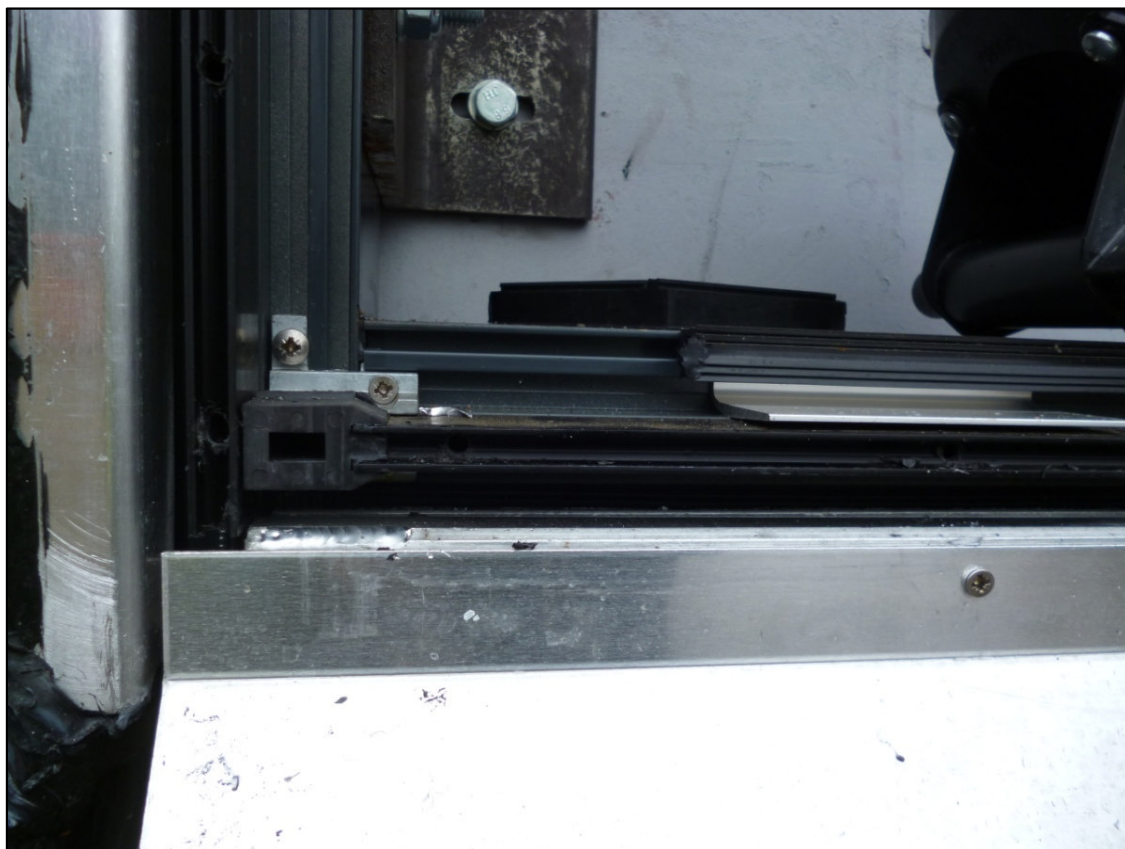
PHOTO 1010970

BOTTOM CORNER OF SAMPLE WITH GLASS REMOVED

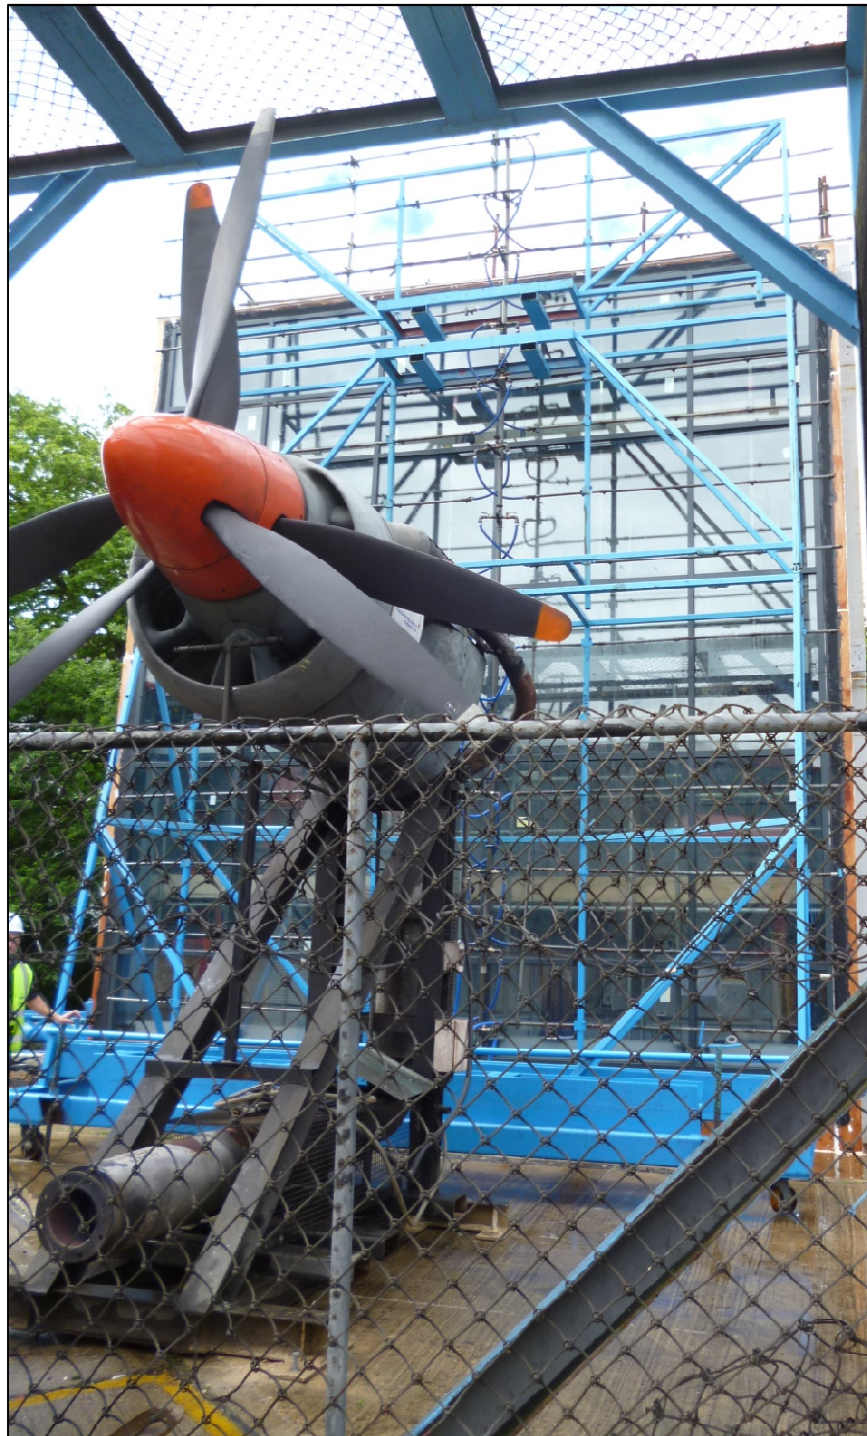
PHOTO 1010854

A wind generator was mounted adjacent to the external face of the sample and used to create positive pressure differentials during dynamic testing. The wind generator comprised a piston type aero-engine fitted with 4 m diameter contra-rotating propellers.

WIND GENERATOR
