**Testing of Smart
Architectural Aluminium
Limited's Visofold 1000
folding doorset to the
requirements of Annex
A and B of PAS 24:2012**

18 August 2014

Test report number 292871

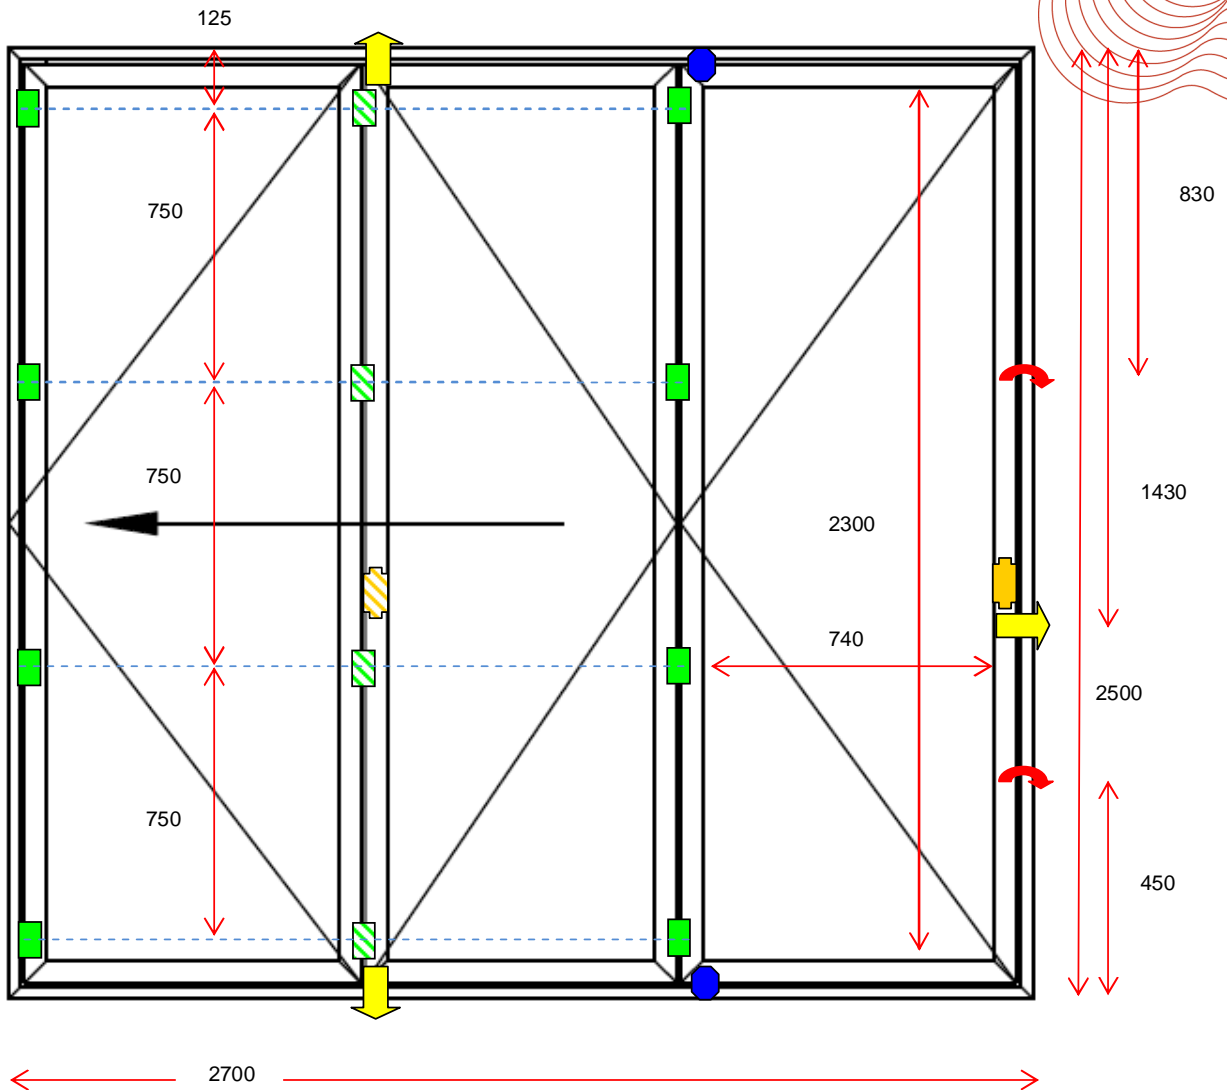
Figure 1 Specimen 292871/01 (external view)

-   Hook bolt
-   Hinge (Internal face)
-   Hinge
-   Key lock (Internal face)
-   Key and handle
-   Deadbolt/shootbolt
-   Hinge bolt
-   Locking cam

All dimensions in mm

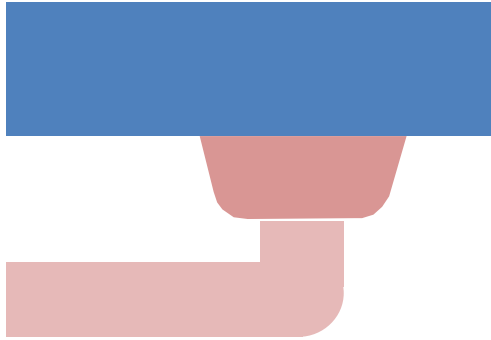
Specimen 292871/02 was identical to specimen 292871/01 with the exception of the handle set. The apparent difference between the handle sets was their horizontal cross sectional profile. The cross-sectional profiles are shown below. The client advised the incorrect handle set was installed on specimen 292871/02.

Horizontal cross-section of handle set on specimen 292871/01

* This is based on the doorset being fitted with a handle set identical to that incorporated on specimen 292871/01.

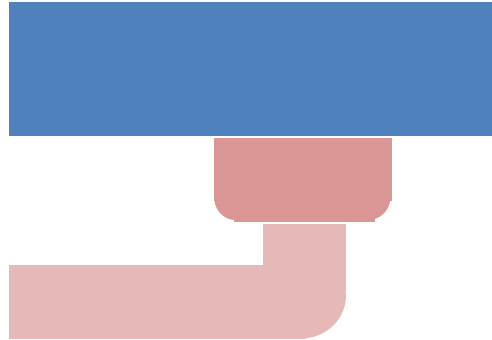
Horizontal cross-section of handle set on specimen 292871/02
