Test Report No: TR 264-14  
Date: 15<sup>th</sup> September 2014

Smart Systems Ltd double pivot hinged  
door set

PAS 24:2012

Test of: Smart Systems Ltd double pivot hinged door set with 2 x Sentinel 6 locks and low aluminium threshold

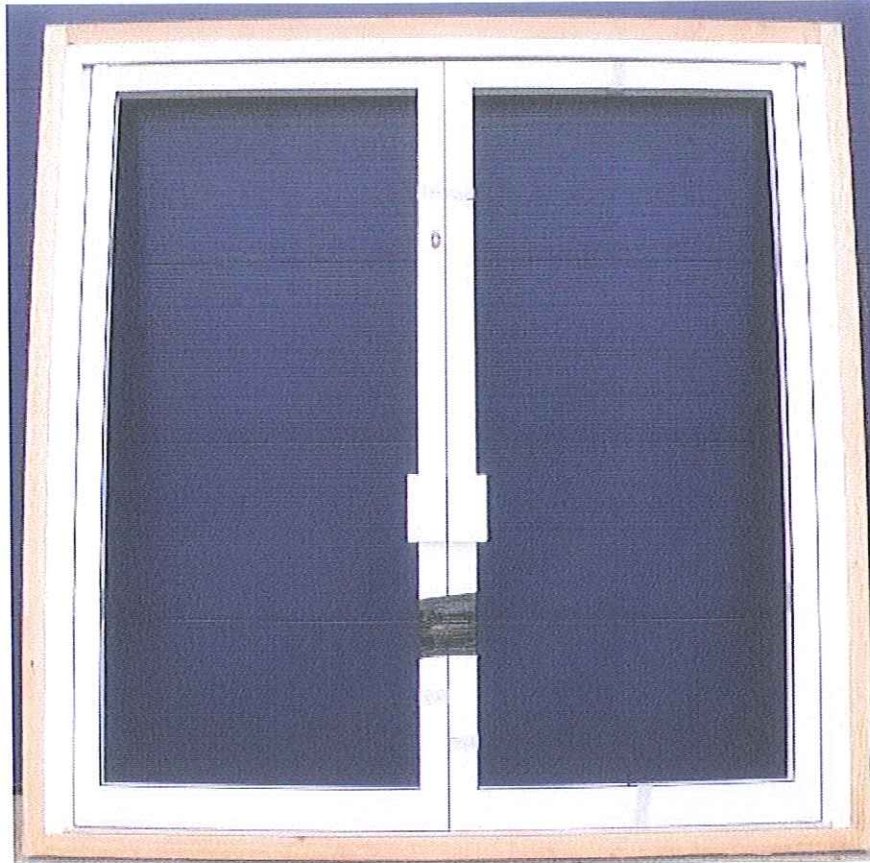
Samples were received in a good condition

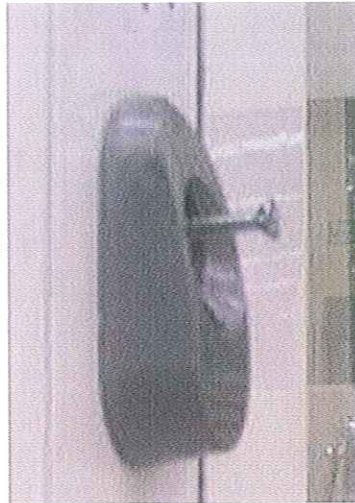
Sample during clause A.3.3 Part 2

A 3.9mm self cutting screw was inserted into the keyway – 1 minute 10 seconds

The screw was then levered with the torque wrench until the screw lost traction and pulled from the cylinder – 1 minute 25 seconds

Total test time 1 minute 25 seconds. The door remained secure

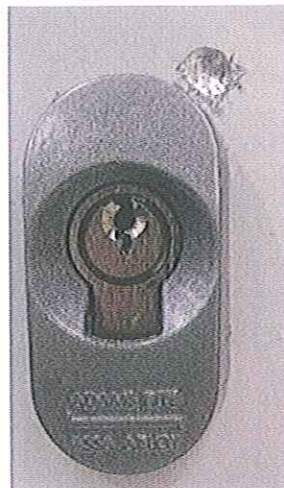
Sample following clause B.4.4.4

The 6mm wood chisel was used in an attempt to create a hole through the skin of the leaf near the lower locking unit just above the cylinder. Following 3 minutes only the first skin was damaged with no access gained Pass
